# Millaa Millaa Energy Monitoring Insights

Inferring network-side power quality parameters from household-level energy monitoring

Dr Stephen Snow, School of Architecture | The University of Queensland  
Email: [s.snow@uq.edu.au](mailto:s.snow@uq.edu.au)

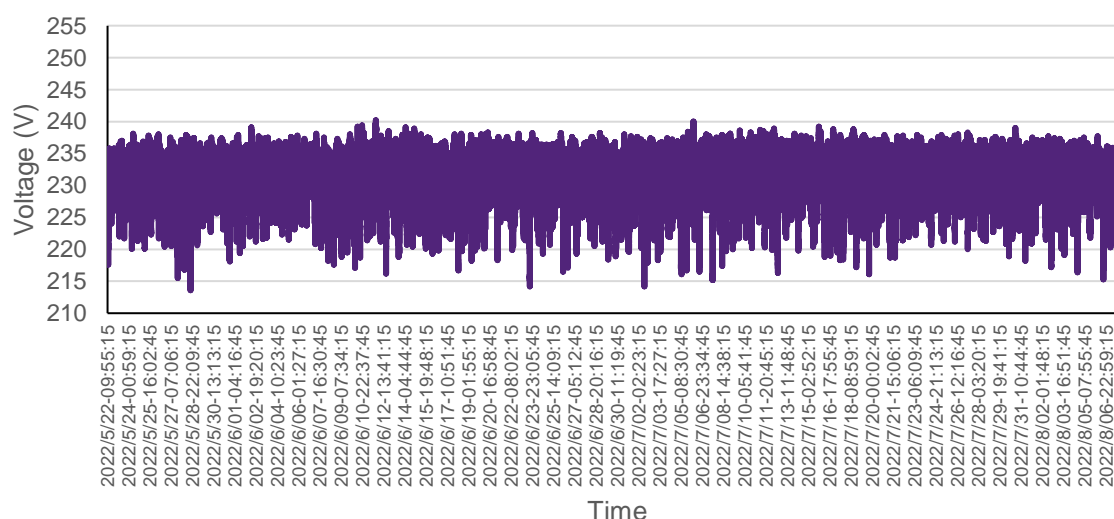
Based on these voltage plots, it can be stated that some feeders in the Millaa Millaa township are experiencing power quality issues such as overvoltage. Note that not all households with Powersensors provided valid data for Voltage and/or Outage. Only those with valid data are presented here:

**Figure 4a:** Voltage readings May-August 2022 from house ID "0gg" likely to be connected to SS1926 transformer

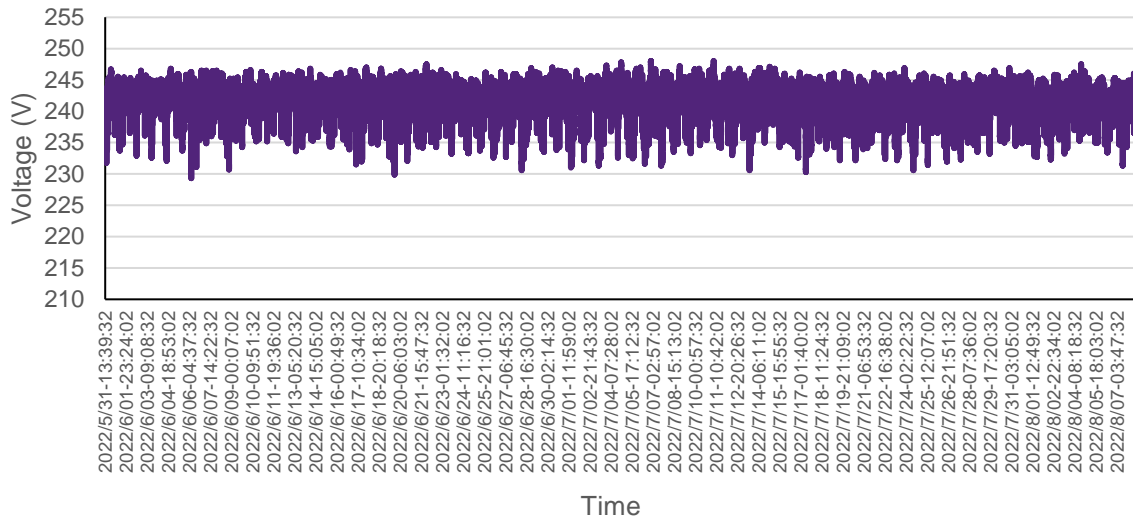
**Figure 4b:** Voltage readings May-August 2022 from house ID “528” likely to be connected to SS1256 transformer

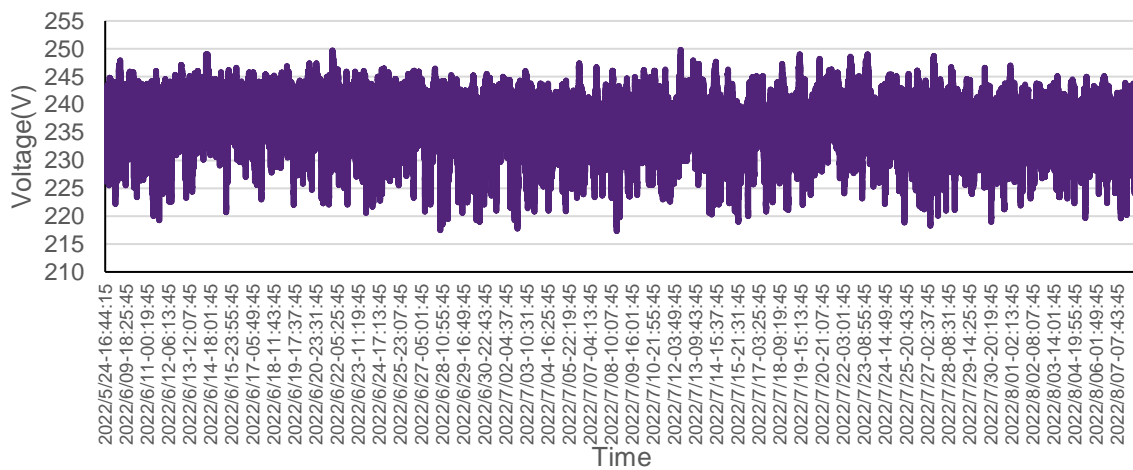
**Figure 4c:** Voltage readings May-August 2022 from house ID “Bqv” likely to be connected to SS10112 transformer

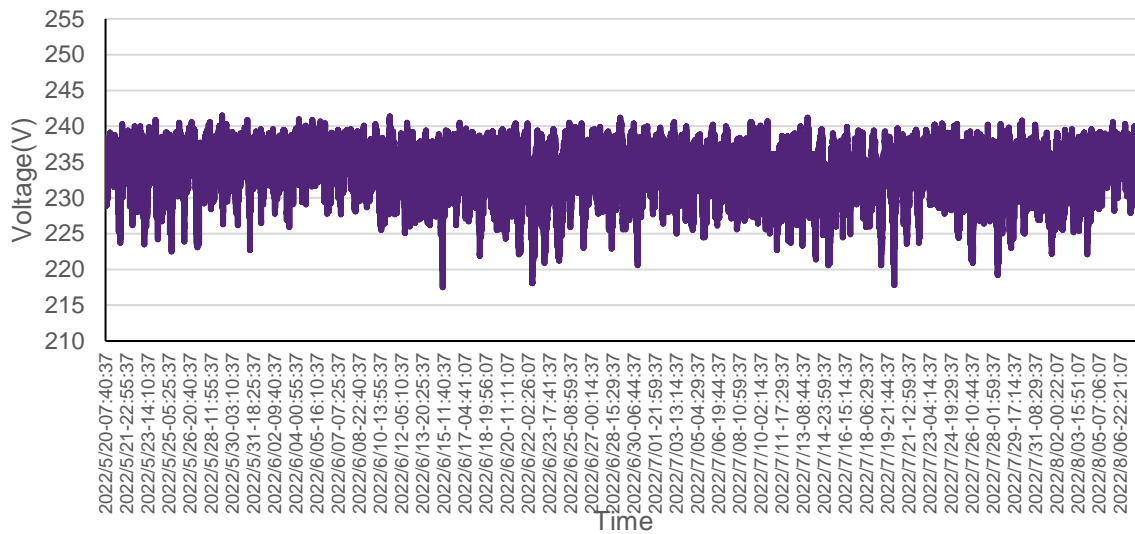
**Figure 4d:** Voltage readings May-August 2022 from house ID “CeY” likely to be connected to SS1926 transformer

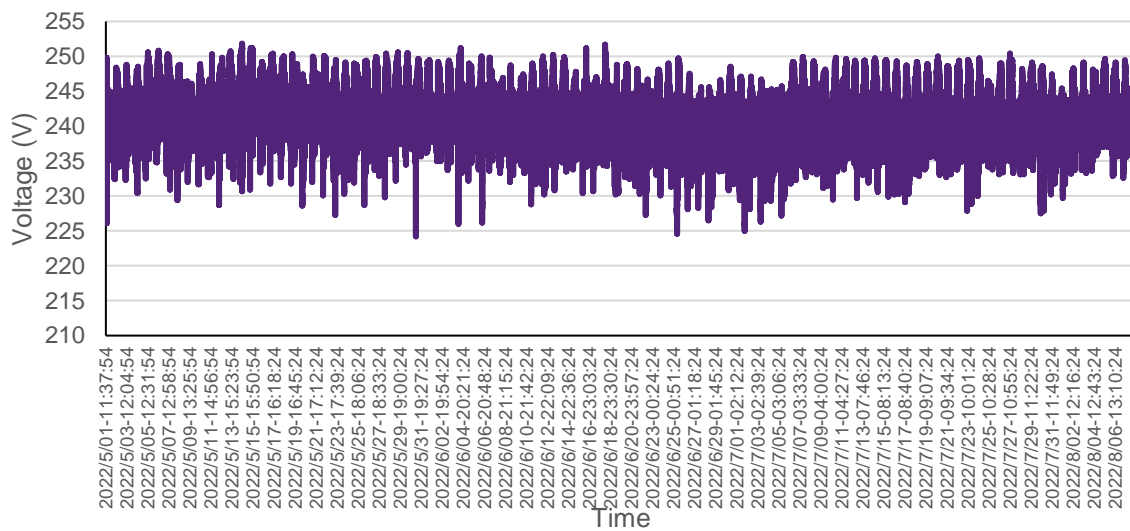
**Figure 4e:** Voltage readings May-August 2022 from house ID “EqL” likely to be connected to SS1256 transformer

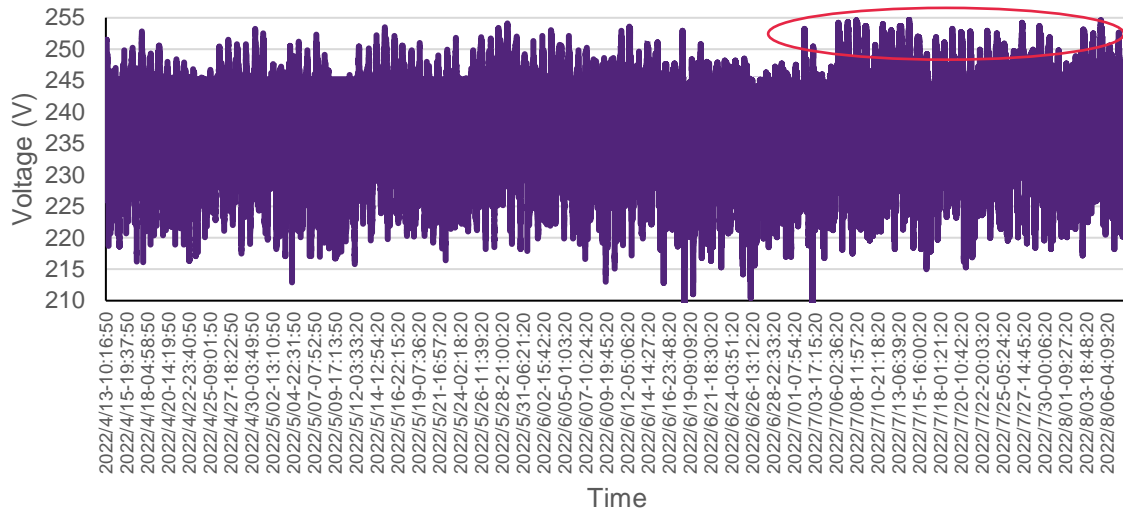
**Figure 4f:** Voltage readings May-August 2022 from house ID “r4w” likely to be connected to SS10112 transformer

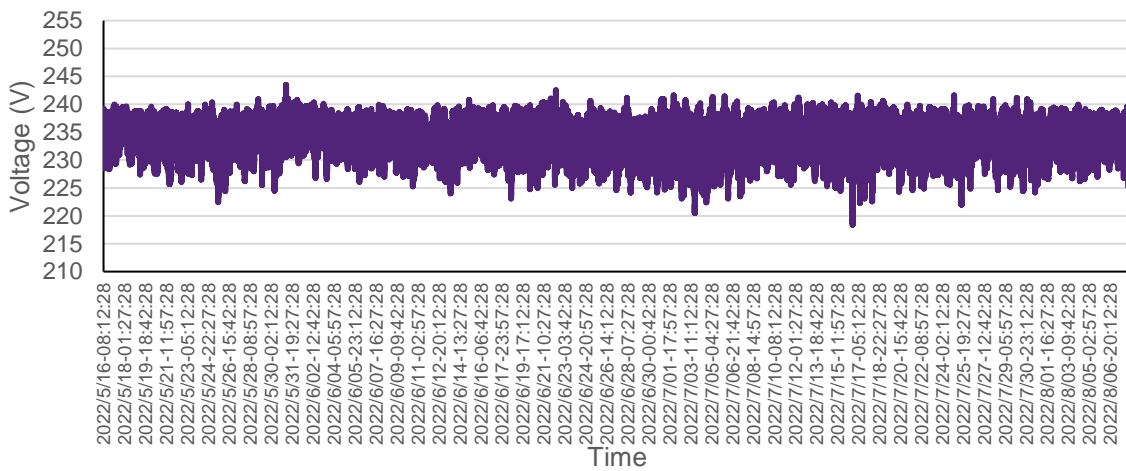
**Figure 4g:** Voltage readings May-August 2022 from house ID “tuK” likely to be connected to SS2488 transformer

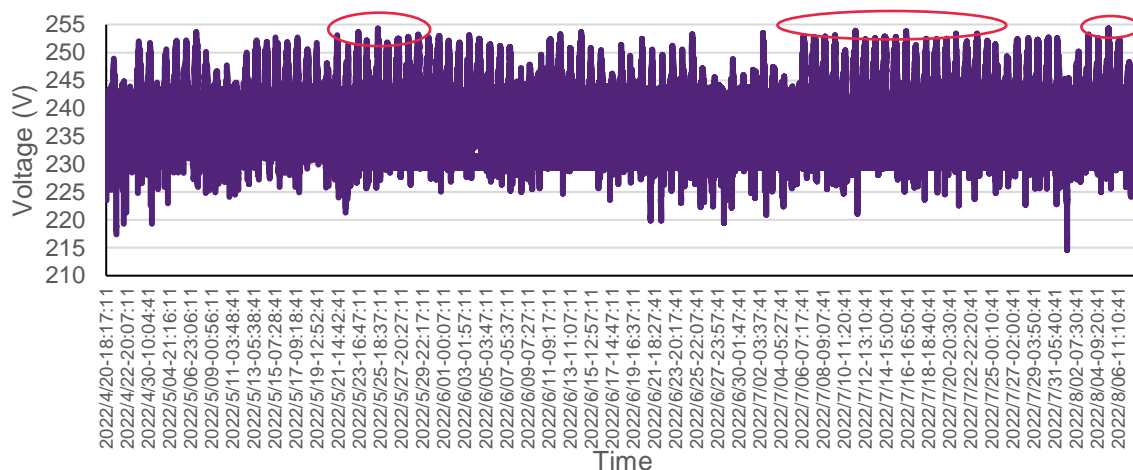
**Figure 4h:** Voltage readings May-August 2022 from house ID “Zly” likely to be connected to SS1256 transformer

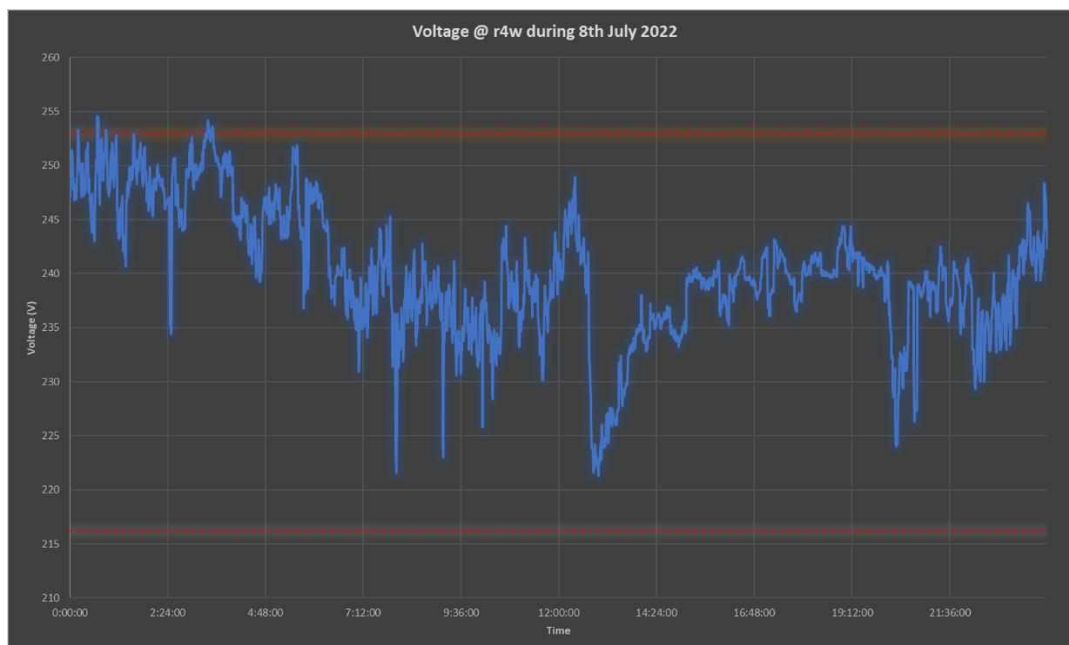
Close inspection was carried out on individual over-voltage events on each premises. Figure 5 presents an example of this inspection, showing a 24 hour period in which over voltage events were recorded. In each case, over-voltage events were short in duration (typically 1-5 minutes). meaning they would not be picked up on feeder level data monitored by the network, given (a) feeder level data covers a far larger area and (b) is comprised of 30 minute averages, meaning short duration (1-5 minute) exceedences would be lost.

**Figure 5:** Voltage measurements at a dwelling during a 24 hour period where exceedences were recorded. Red lines indicate upper and lower bounds of AS 60038 (216V to 253V)

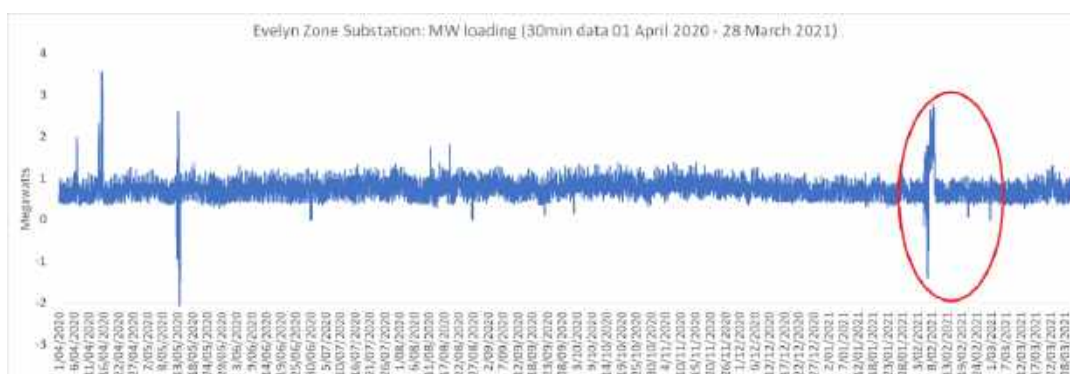
**Evelyn Substation data:** 30-minute time series data is publicly available and downloaded from the Ergon Distribution Annual Planning Report Map<sup>2</sup>. The most recent period of downloadable data (at the time of writing) is 01 April 2020 to 28 March 2021 (before Powersensors or Phisavers were installed). The data shows two instances of negative MW loading experienced in May 2020 and February 2021 as well as other less significant fluctuations (Figure 6a, 6b). We speculate the negative loadings may indicate power to the substation or to certain feeders being re-routed, however we cannot confirm the cause.

The red circles in Figures 6a and 6b point to the same event, which is described below.

**Figure 6a:** Loading data on Evelyn Zone substation from 1/4/20 to 28/3/21

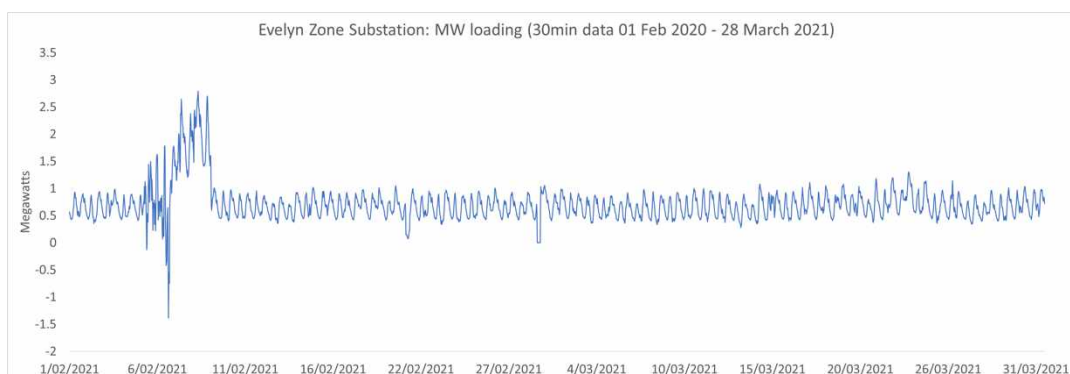
**Figure 6b:** Loading data on Evelyn Zone substation from 1/2/21 to 28/3/21 (this is a zoom in on the red circled portion of Figure 6a).

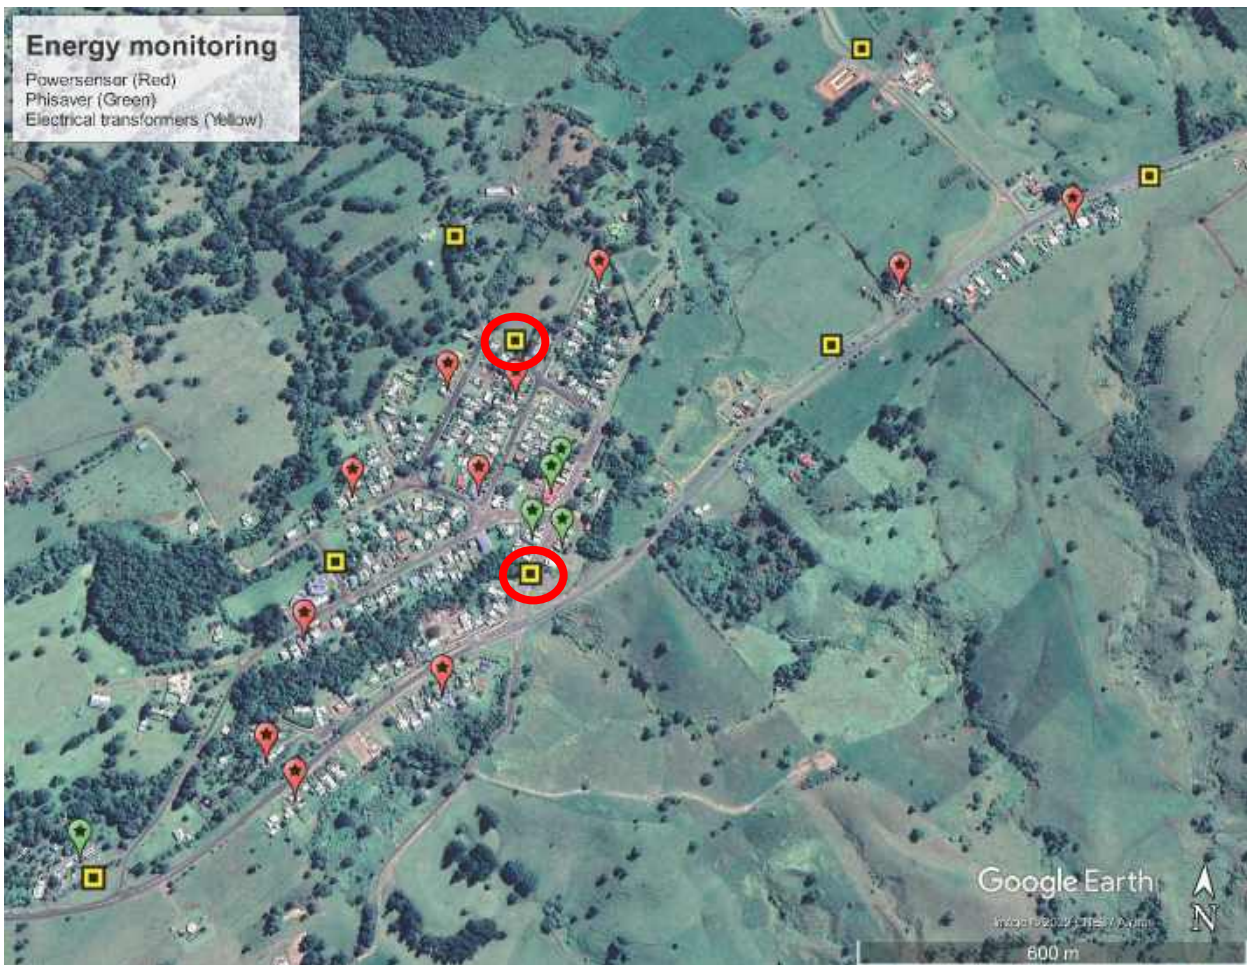
**Figure 7:** Location of SS10112 and SS1256 transformers (denoted by red circles around the yellow transformers). This figure is an adaptation of Figure 3 above

It is not possible to determine which transformer which houses are connected to, but based on a best guess, we expect that the houses involved in the simultaneous outage events (Table 2) were connected to SS10112 and SS1256 distribution transformers, suggestive that both these transformers lost power, while the lack of simultaneous outage reports from all other Powersensors suggests that the outages were localised to these two transformers only.
